Shrinkage leads to indent fractures in stone

By Donato Pompo CTC CMR CSI CDT MBA,
Ceramic Tile and Stone Consultants, Inc.

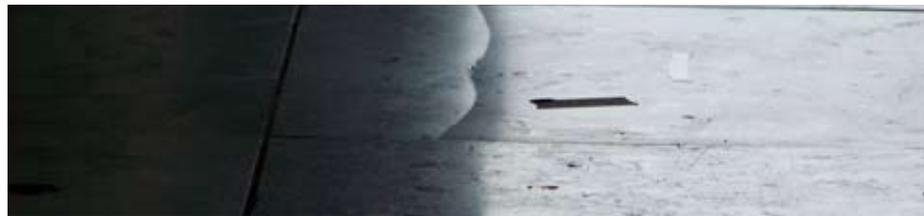
Indent fractures are not easy to see; typically they can only be seen from an angle when light reflects off them.

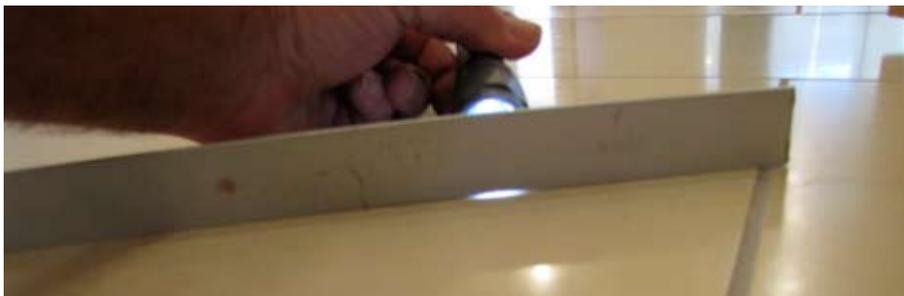
If you put a straight edge over the indent fracture and shine a flashlight from the back of the straight edge, the light shines through at the fracture, indicating a low spot.

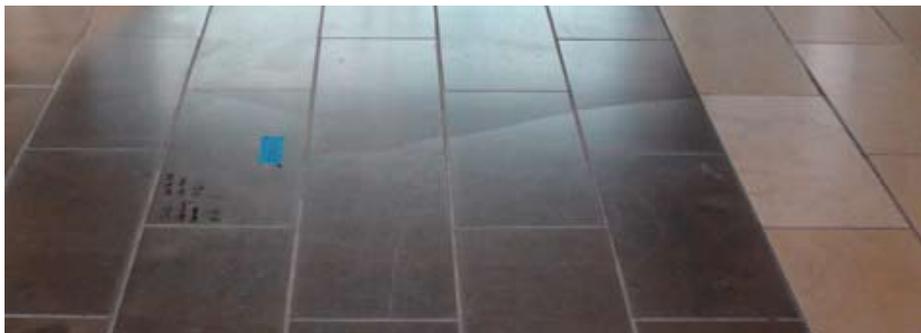
An indent fracture is caused by bottom of the stone shortening from deformation caused by the thin-set shrinkage, resulting in the crack. The top surface of the stone is drawn down at the crack location resulting in the indent.

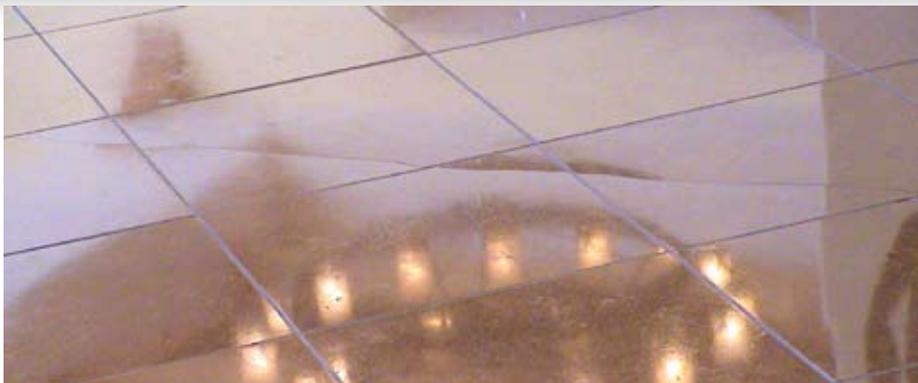
Very thick and/or wet thin-set mortar applications, combined with resilient membranes that don't allow the mortar to restrain the thin-set mortar can contribute to indent fractures.

Make sure you adjust your substrate to meet ANSI A108 flatness requirements. Then use thin-bed mortar, limiting the thickness to 1/4." Use a rapid-setting thin-set to help minimize the extent of shrinkage since it cures faster. A membrane with less resilience can

also help to restrain the thin-set mortar if it is properly attached. Use dry-pack mortars for wet-setting stone on floors to limit the amount of shrinkage and the amount of moisture to which the stone is subjected. Make sure your wire reinforcement is suspended within one-third to one-half the thickness of the mortar bed for non-bonded applications to help minimize shrinkage.
