Donato Pompo and Richard Goldberg

By **Bart Bettiga** January 1, 2021

Leading tile industry consultants

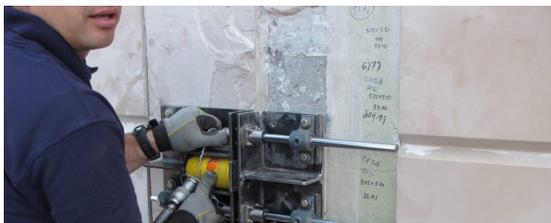
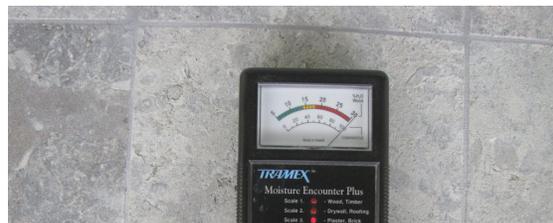
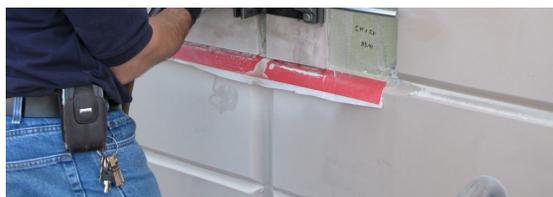
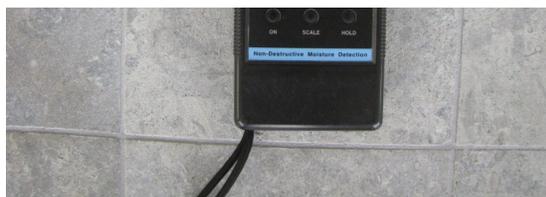
Common tests that industry consultants conduct include checking for moisture in the substrate and testing an assembly for adhesive bond and performance.

Pompo: It is important to identify a problem on a job and not focus on the symptom, because there are often many factors involved when something is wrong. It is never our intent to condemn a project. We look for options to preserve the project, where repairs and remediation can be done to solve the problem. Some of the tests we perform include a tensile pull test, to determine how well the material is bonded to the substrate. This is a way to determine coverage or excessive voids that are not bonded.

Goldberg: Another common test is conducted with an electronic moisture meter, which measures moisture content in the top one inch of a cementitious surface. It basically tells you whether there is a problem with moisture content, which would require further investigation. We also perform core tests often where we drill through the full tile assembly, take the cores into a lab, and evaluate the entire system.

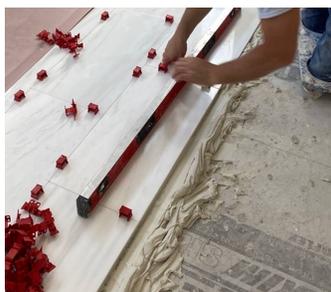
Inappropriate use of material – such as using thin-set mortar to build up or level a substrate – is a common error made in the field.

Pompo: Agreed. They often find out the substrate is not adequate and then discussion centers on who is going to pay for this to be fixed. Often what happens is the tile contractor tries to fix the problem with inadequate materials, like thinset that is not designed for leveling. When companies cut corners like this, problems undoubtedly follow.
