Shrinkage leads to indent fractures in stone

By Donato Pompo CTC CMR CSI CDT MBA,
Ceramic Tile and Stone Consultants, Inc.

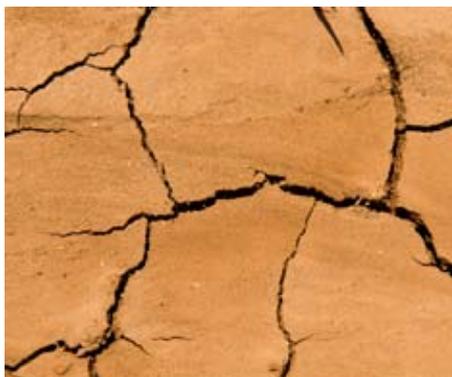
membrane allowed the indent fracture to occur. The total force of shrinkage resulting from thicker applications of thin-set mortar will impart greater stresses in the stone than a thinner application, causing more deformation (strain) or shrinkage. This is compounded if the thin-set is also installed over a resilient membrane, because the membrane isn't as effective in restraining the thin-set mortar as a rigid concrete substrate would. Instead, the thin-set mortar under the stone dries in a manner similar to a dry lake bed, with compression within some areas of the thin-set that results in tension in other areas, creating cracking in the

thin-set. The crack then works its way up through some of the stone, but does not appear as a crack at the surface.

An indent fracture is caused by bottom of the stone shortening from deformation caused by the thin-set shrinkage, resulting in the crack. The top surface of the stone is drawn down at the crack location resulting in the indent.

Very thick and/or wet thin-set mortar applications, combined with resilient membranes that don't allow the mortar to restrain the thin-set mortar can contribute to indent fractures.

So what can you do to avoid indent fractures? First, follow thin-set mortar manufacturers' recommendations for their products. ANSI now has defined the differences between a medium-bed and thin-bed thin-set mortar, indicating their limitations. A thin-bed mortar cannot be used any thicker than 1/4" or less than 3/32" after the tile is embedded. A medium-bed mortar cannot be any thicker than 3/4" thick after the tile is embedded. ANSI further states that the medium-bed mortar is not intended to be used in truing or leveling underly-
